ROCKER ARM SHAFT

The following shows rocker arm shaft disassembly and assembly procedures.

Application of Modifications

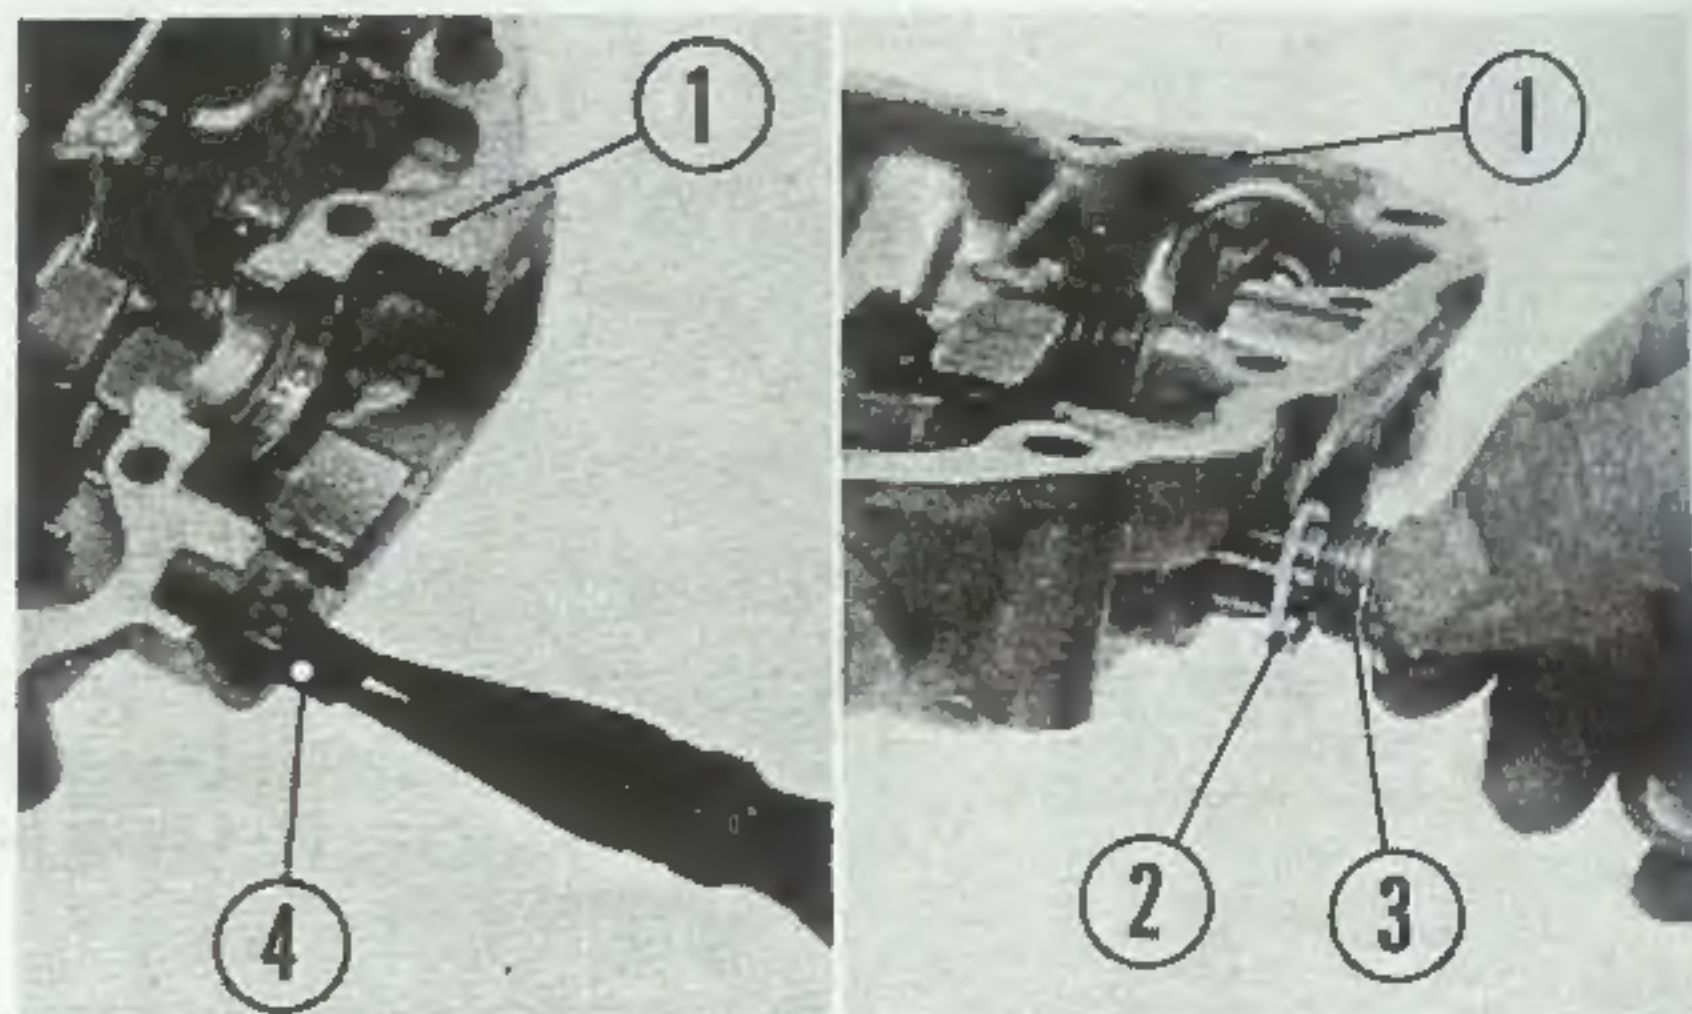
Fig. 1 (1) Cylinder head cover
(2) Sealing washer
(3) Right rocker arm shaft
(4) Left rocker arm shaft

Except that Right rocker arm shaft is removed only loosening bolt.
